# Using Carpenter Additive's Lab to Rapidly Complete a Root Cause Analysis of Powder Contamination

Carpenter Additive was approached by a customer operating an SLM Solutions machine to manufacture a component for an Industrial Gas Turbine application. Cracking was observed in the built component.

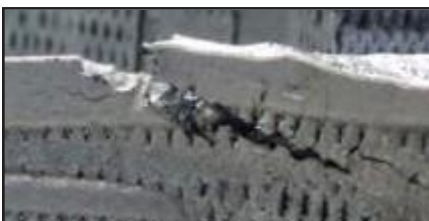
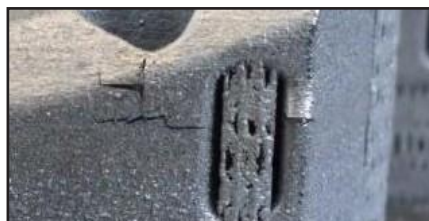
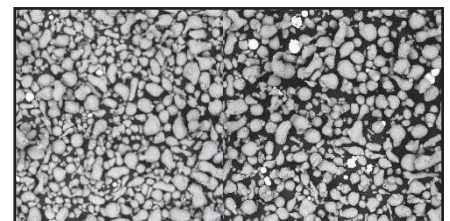
The sample is passed to Carpenter Additive's diagnosis lab. Analysis by SEM EDX revealed that the powder returned from the customer was contaminated. The images below show foreign particles when analyzed using SEM EDX.

Further investigation using Energy-Dispersive X-ray spectroscopy (EDX) enabled Carpenter Additive to identify the particles as Inconel 625.

So just four days after the customer contacted Carpenter Additive, we were able to inform them of contamination and advise that the machine be restocked with only virgin powder from the same lot.

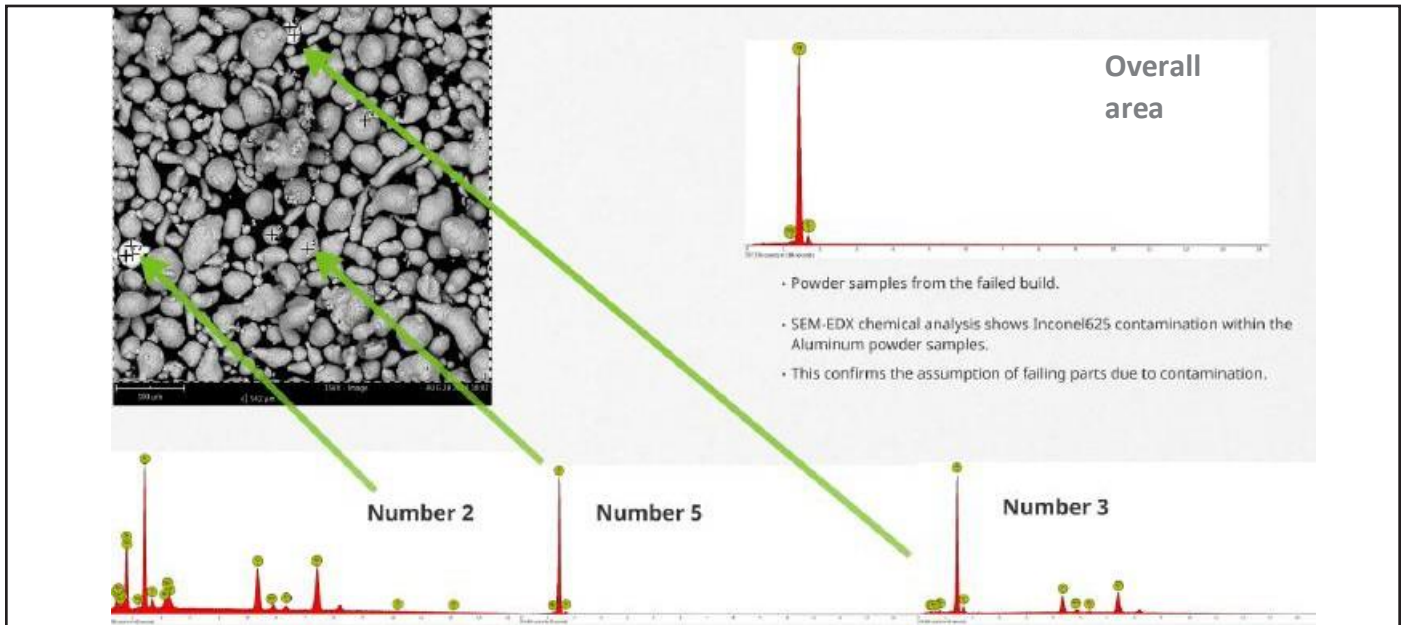
The image in the top left shows two brighter particles in this sample of material. The chart in the top right of the slide shows the analysis for the overall area of the powder whereby it detects Aluminum, Silicon and Magnesium as you would expect for the material.

However, when we analyze the brighter particles more closely you can see that the EDX spectrum has detected Ni, Cr and a number of other peaks. We identified this material as Inconel 625.

On further investigation, the customer confirmed that the machine had been recently changed from Inconel 625 to AlSi10Mg by a relatively junior operator who had not followed cleaning procedures.

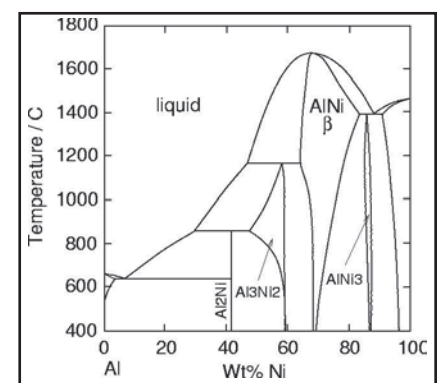
To fully understand the reasons why a small amount of Nickel alloy contamination could cause such devastating effects on the part quality, Carpenter Additive's metallurgists researched the issue. They found that Nickel has a very limited solubility in Aluminum which means that the brittle AlNi phases appeared in the microstructure, resulting in cracked propagation sites.

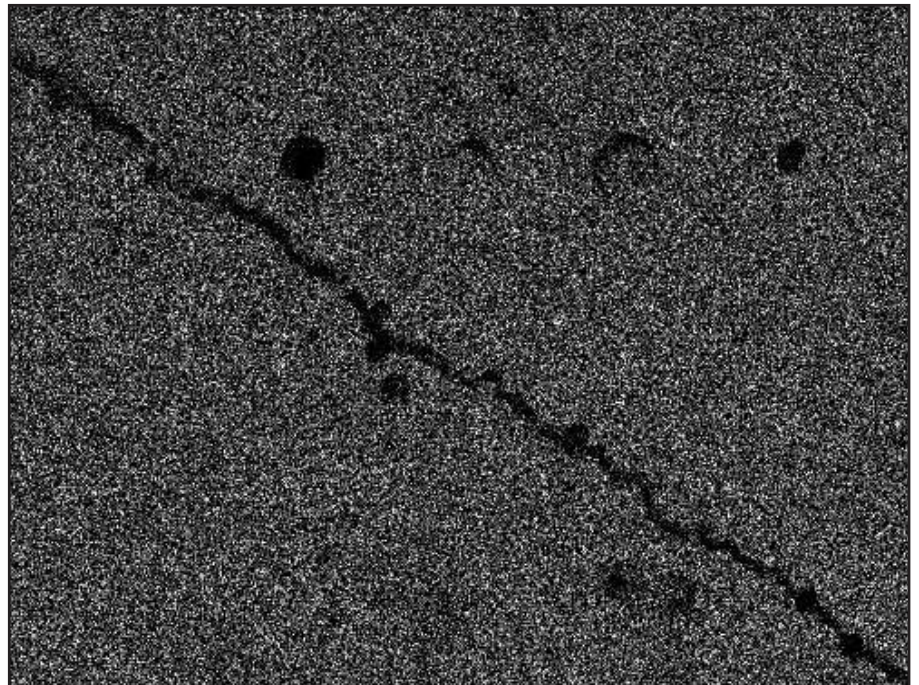
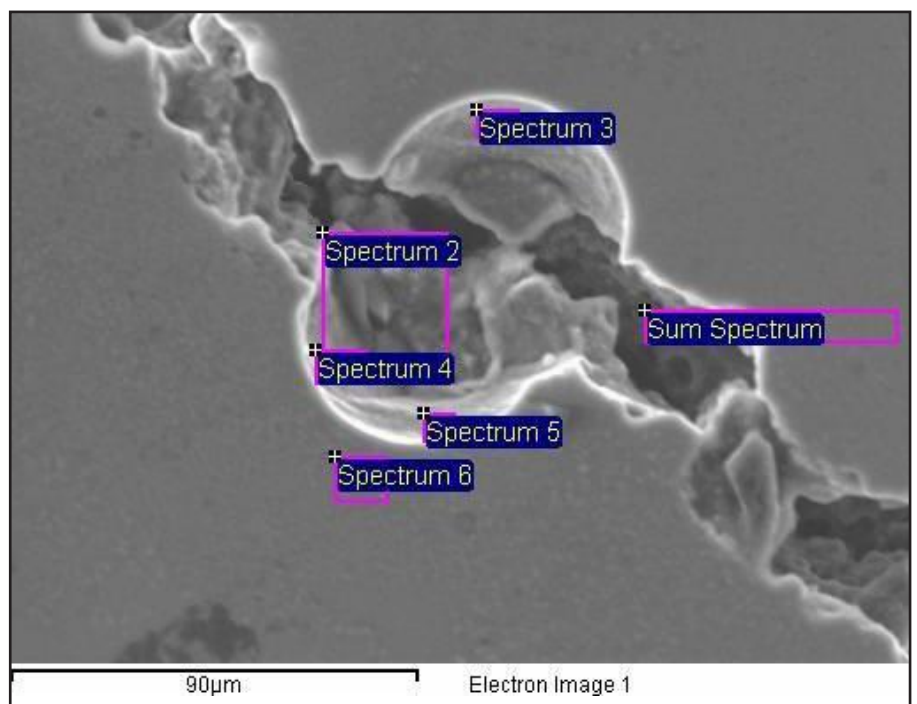
Further analysis of the parts which failed revealed that the Nickel was fairly homogeneously spread throughout the Aluminum matrix of the component. An average of 5.2 wt% could be observed.

In specific areas wt% in excess of 40% could be identified, which indicates that we would have a presence of the very brittle intermetallic phases.

This information was fed back to our customer in America who was very happy to fully understand the issue and has subsequently improved their training techniques and internal procedures.
